Statement of Environmental Particulars for The Wash Shoreline Management Plan 2

Issued August 2010

The Wash Shoreline Management Plan 2

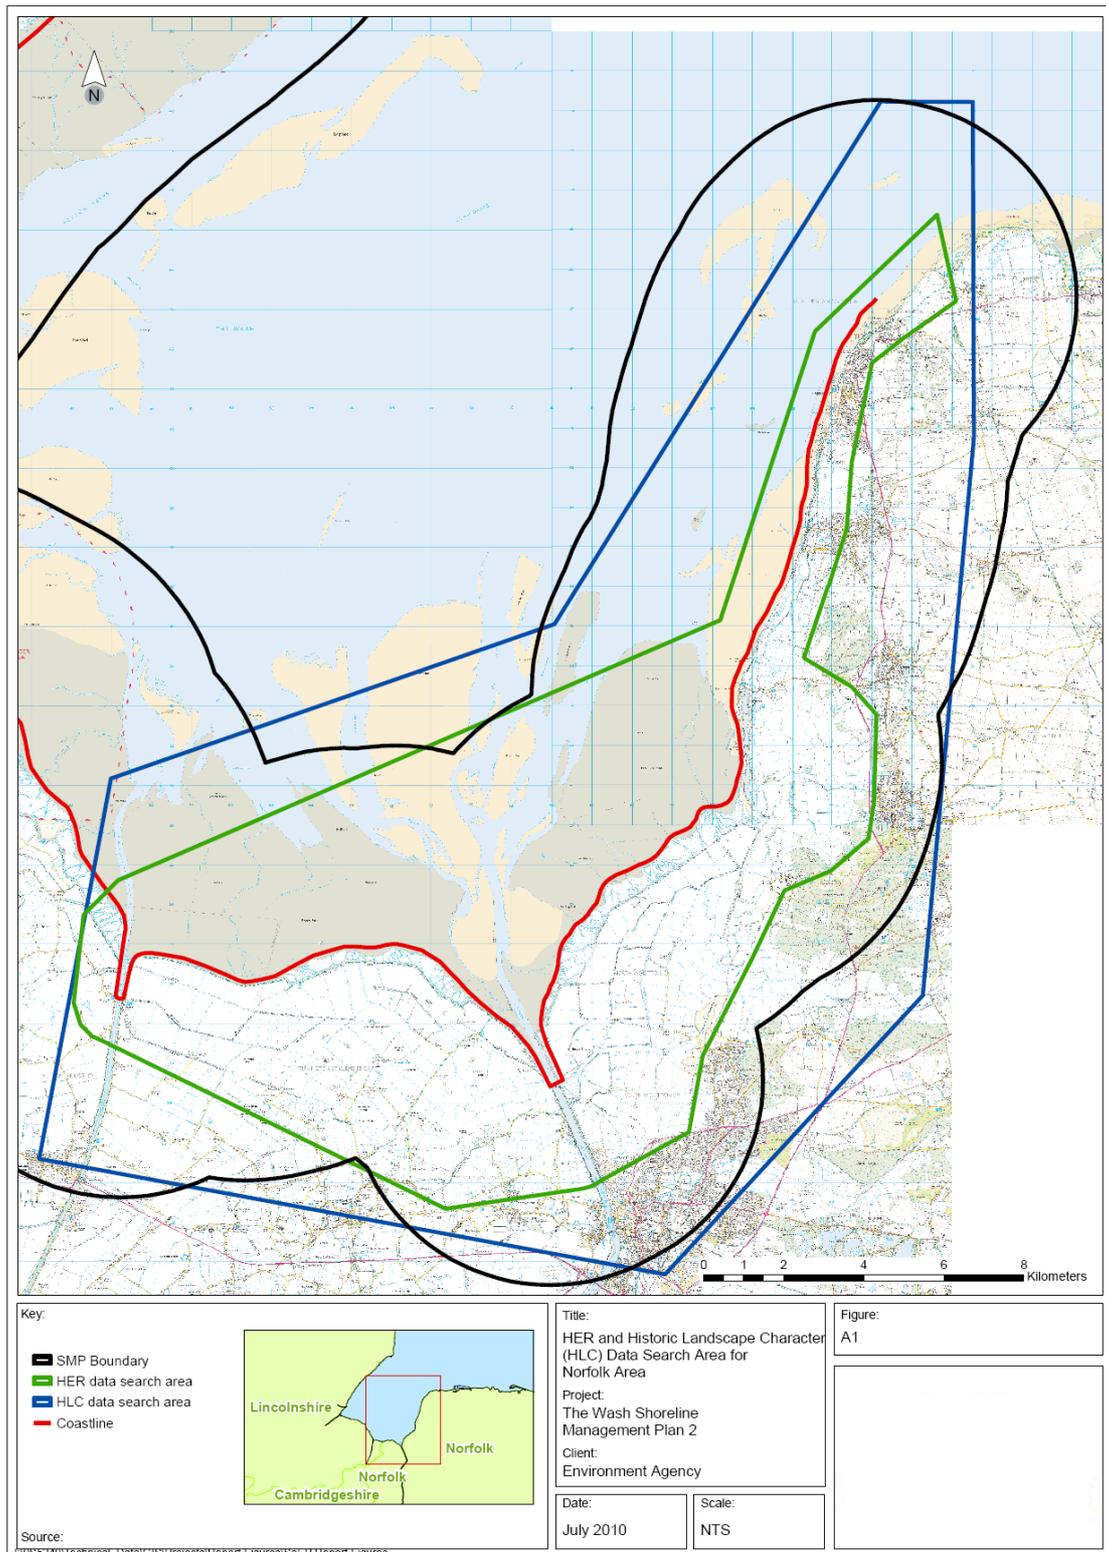
Figure A1 HER and Historic Landscape Character (HLC) Data Search Area for Norfolk area (the Lincolnshire section was covered by a recent RCZAS)

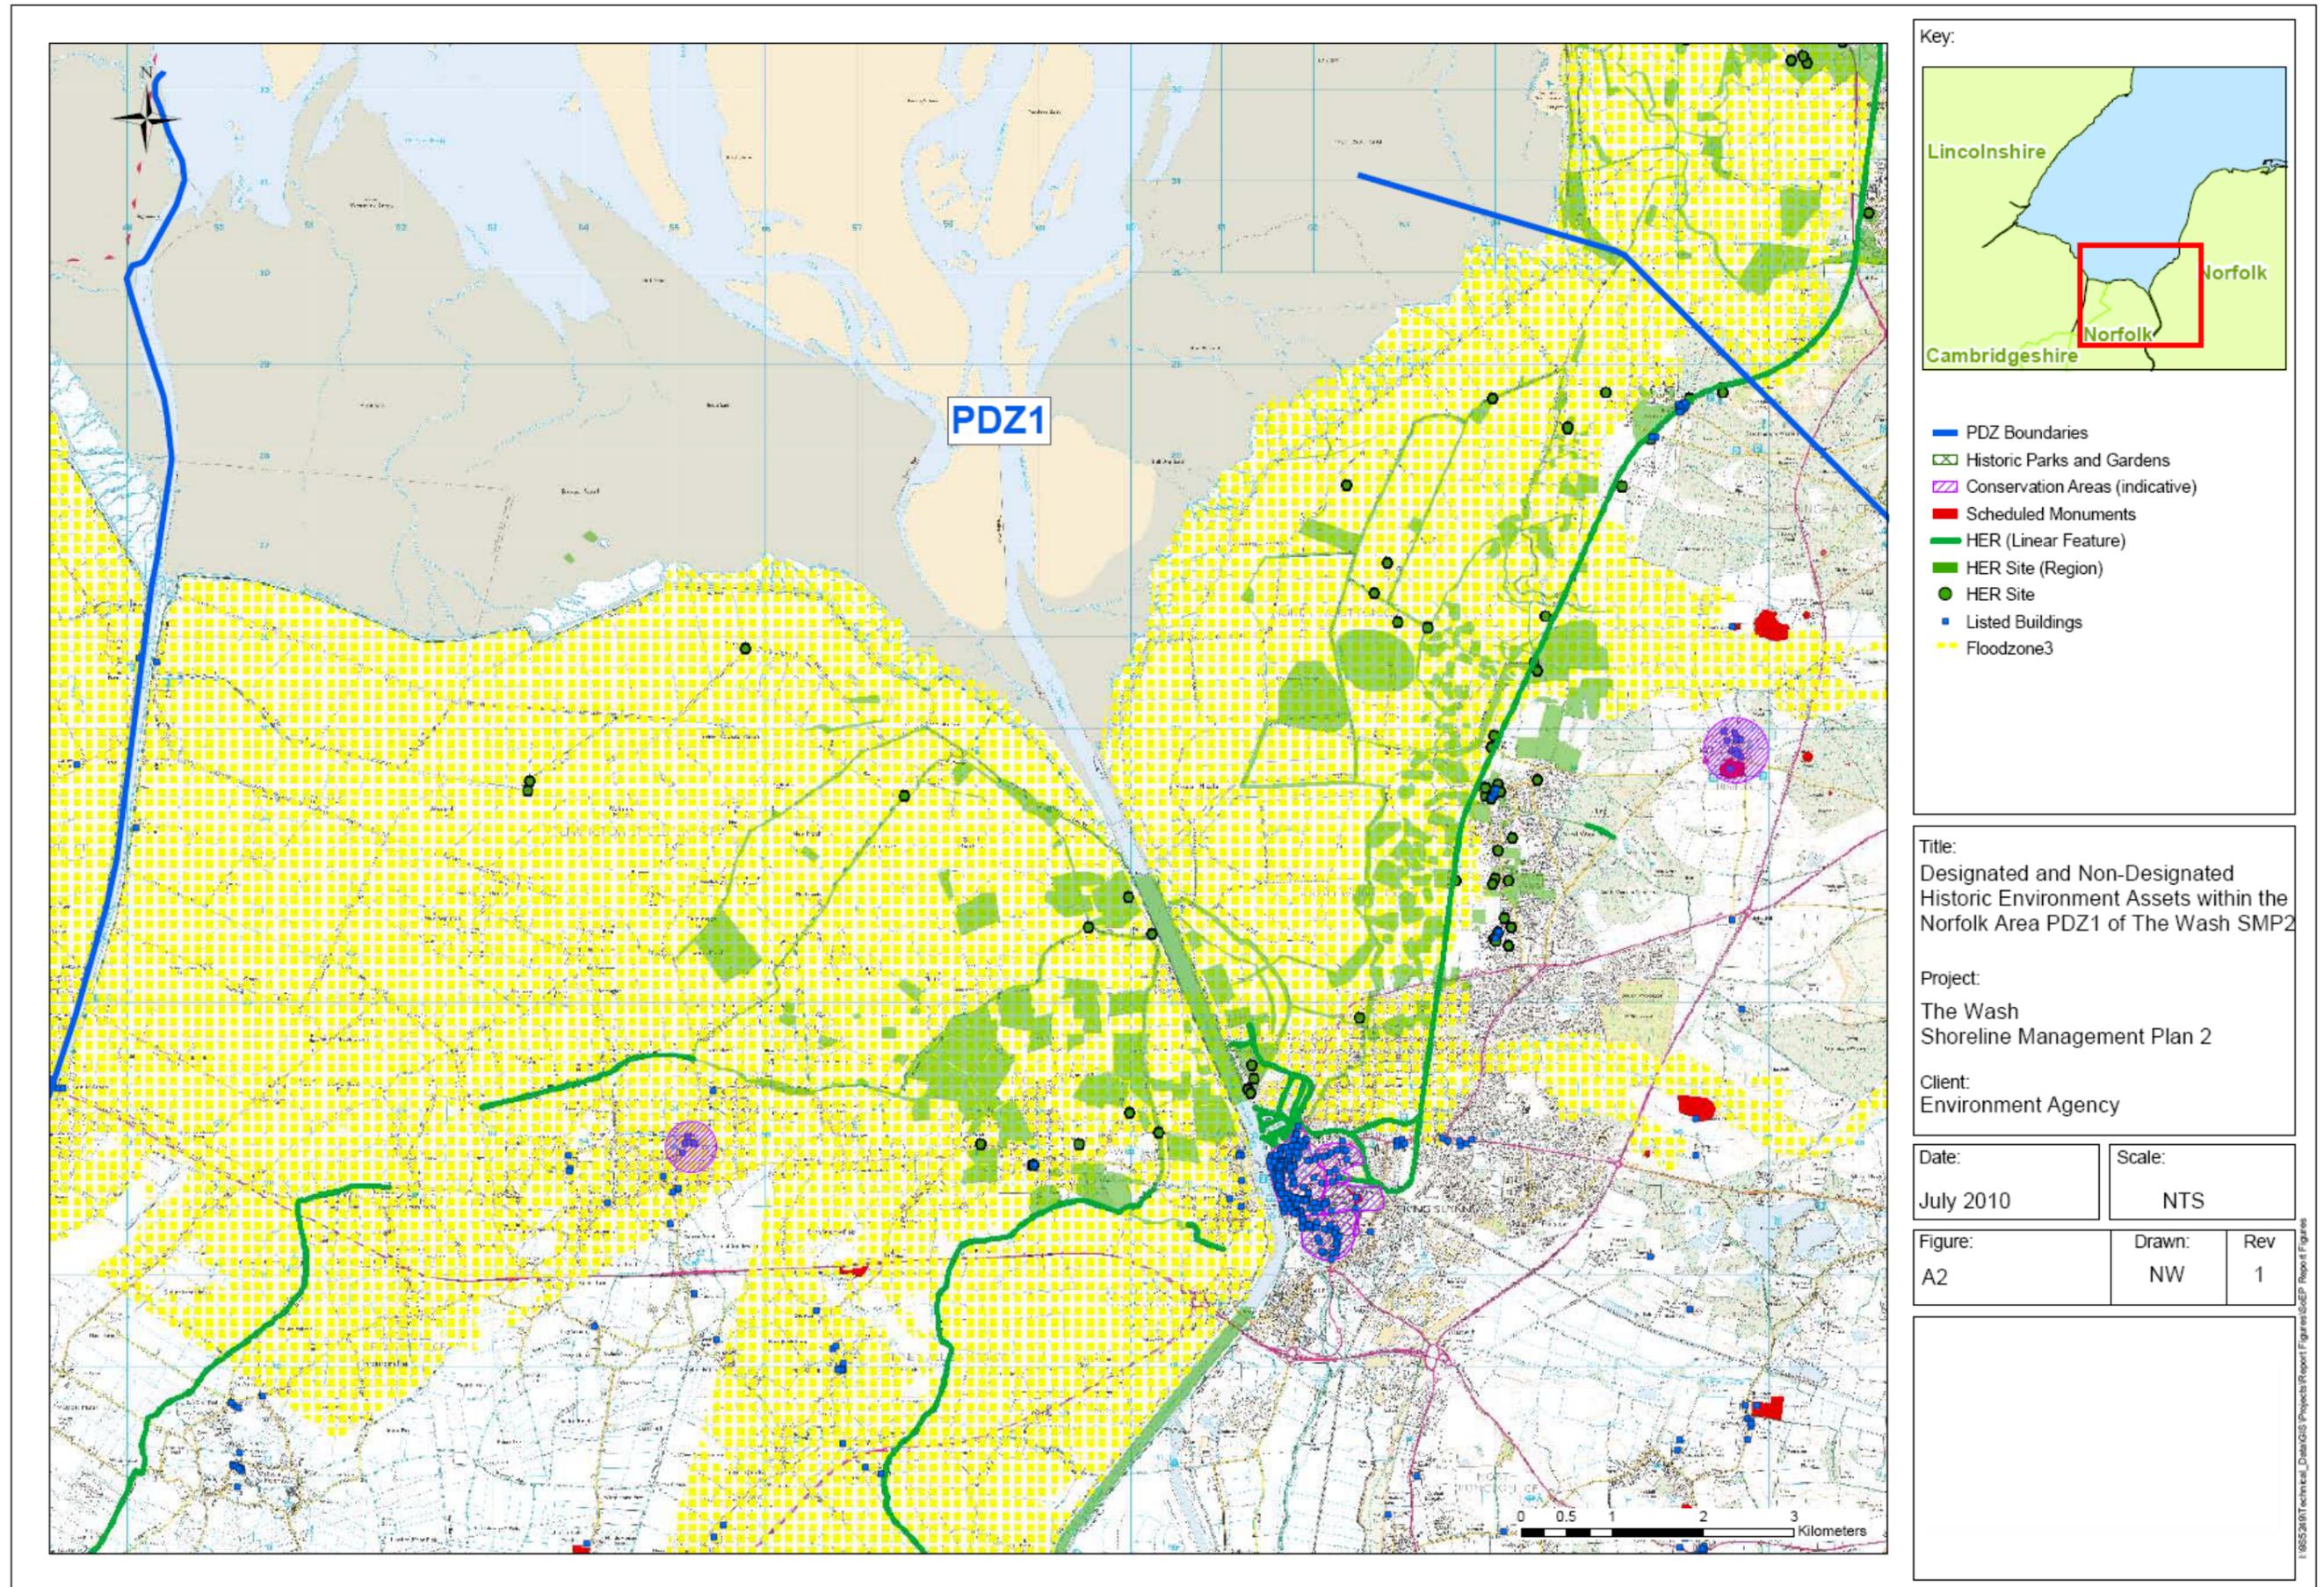
Figure A2 Designated and Non-Designated Historic Environment Assets within the Norfolk Area of PDZ1 of the Wash SMP

- the collection of Listed Buildings in North Wootton and South Wootton;
- the numerous sites and buildings particularly the SM in Castle Rising;
- the medieval settlement at Babingley which is Scheduled;
- the collection of Listed Buildings relating to the Railway Station at Wolferton;
- the Historic Park and Garden at Sandringham;
- the SM and Listed Building at the east end of Dersingham;
- the collection of Listed Buildings in Ingoldisthorpe and Snettisham supported by the Conservation Area in Snettisham;
- the wooded landscape and associated Listed Buildings in Ken Hill Wood;
- the Listed Buildings and Conservation Area in Heacham;
- the Listed Buildings and Conservation Area in Hunstanton;
- the Listed Buildings and Conservation Area in Old Hunstanton; and
- the Parks and Gardens of the Listed Hunstanton Hall.

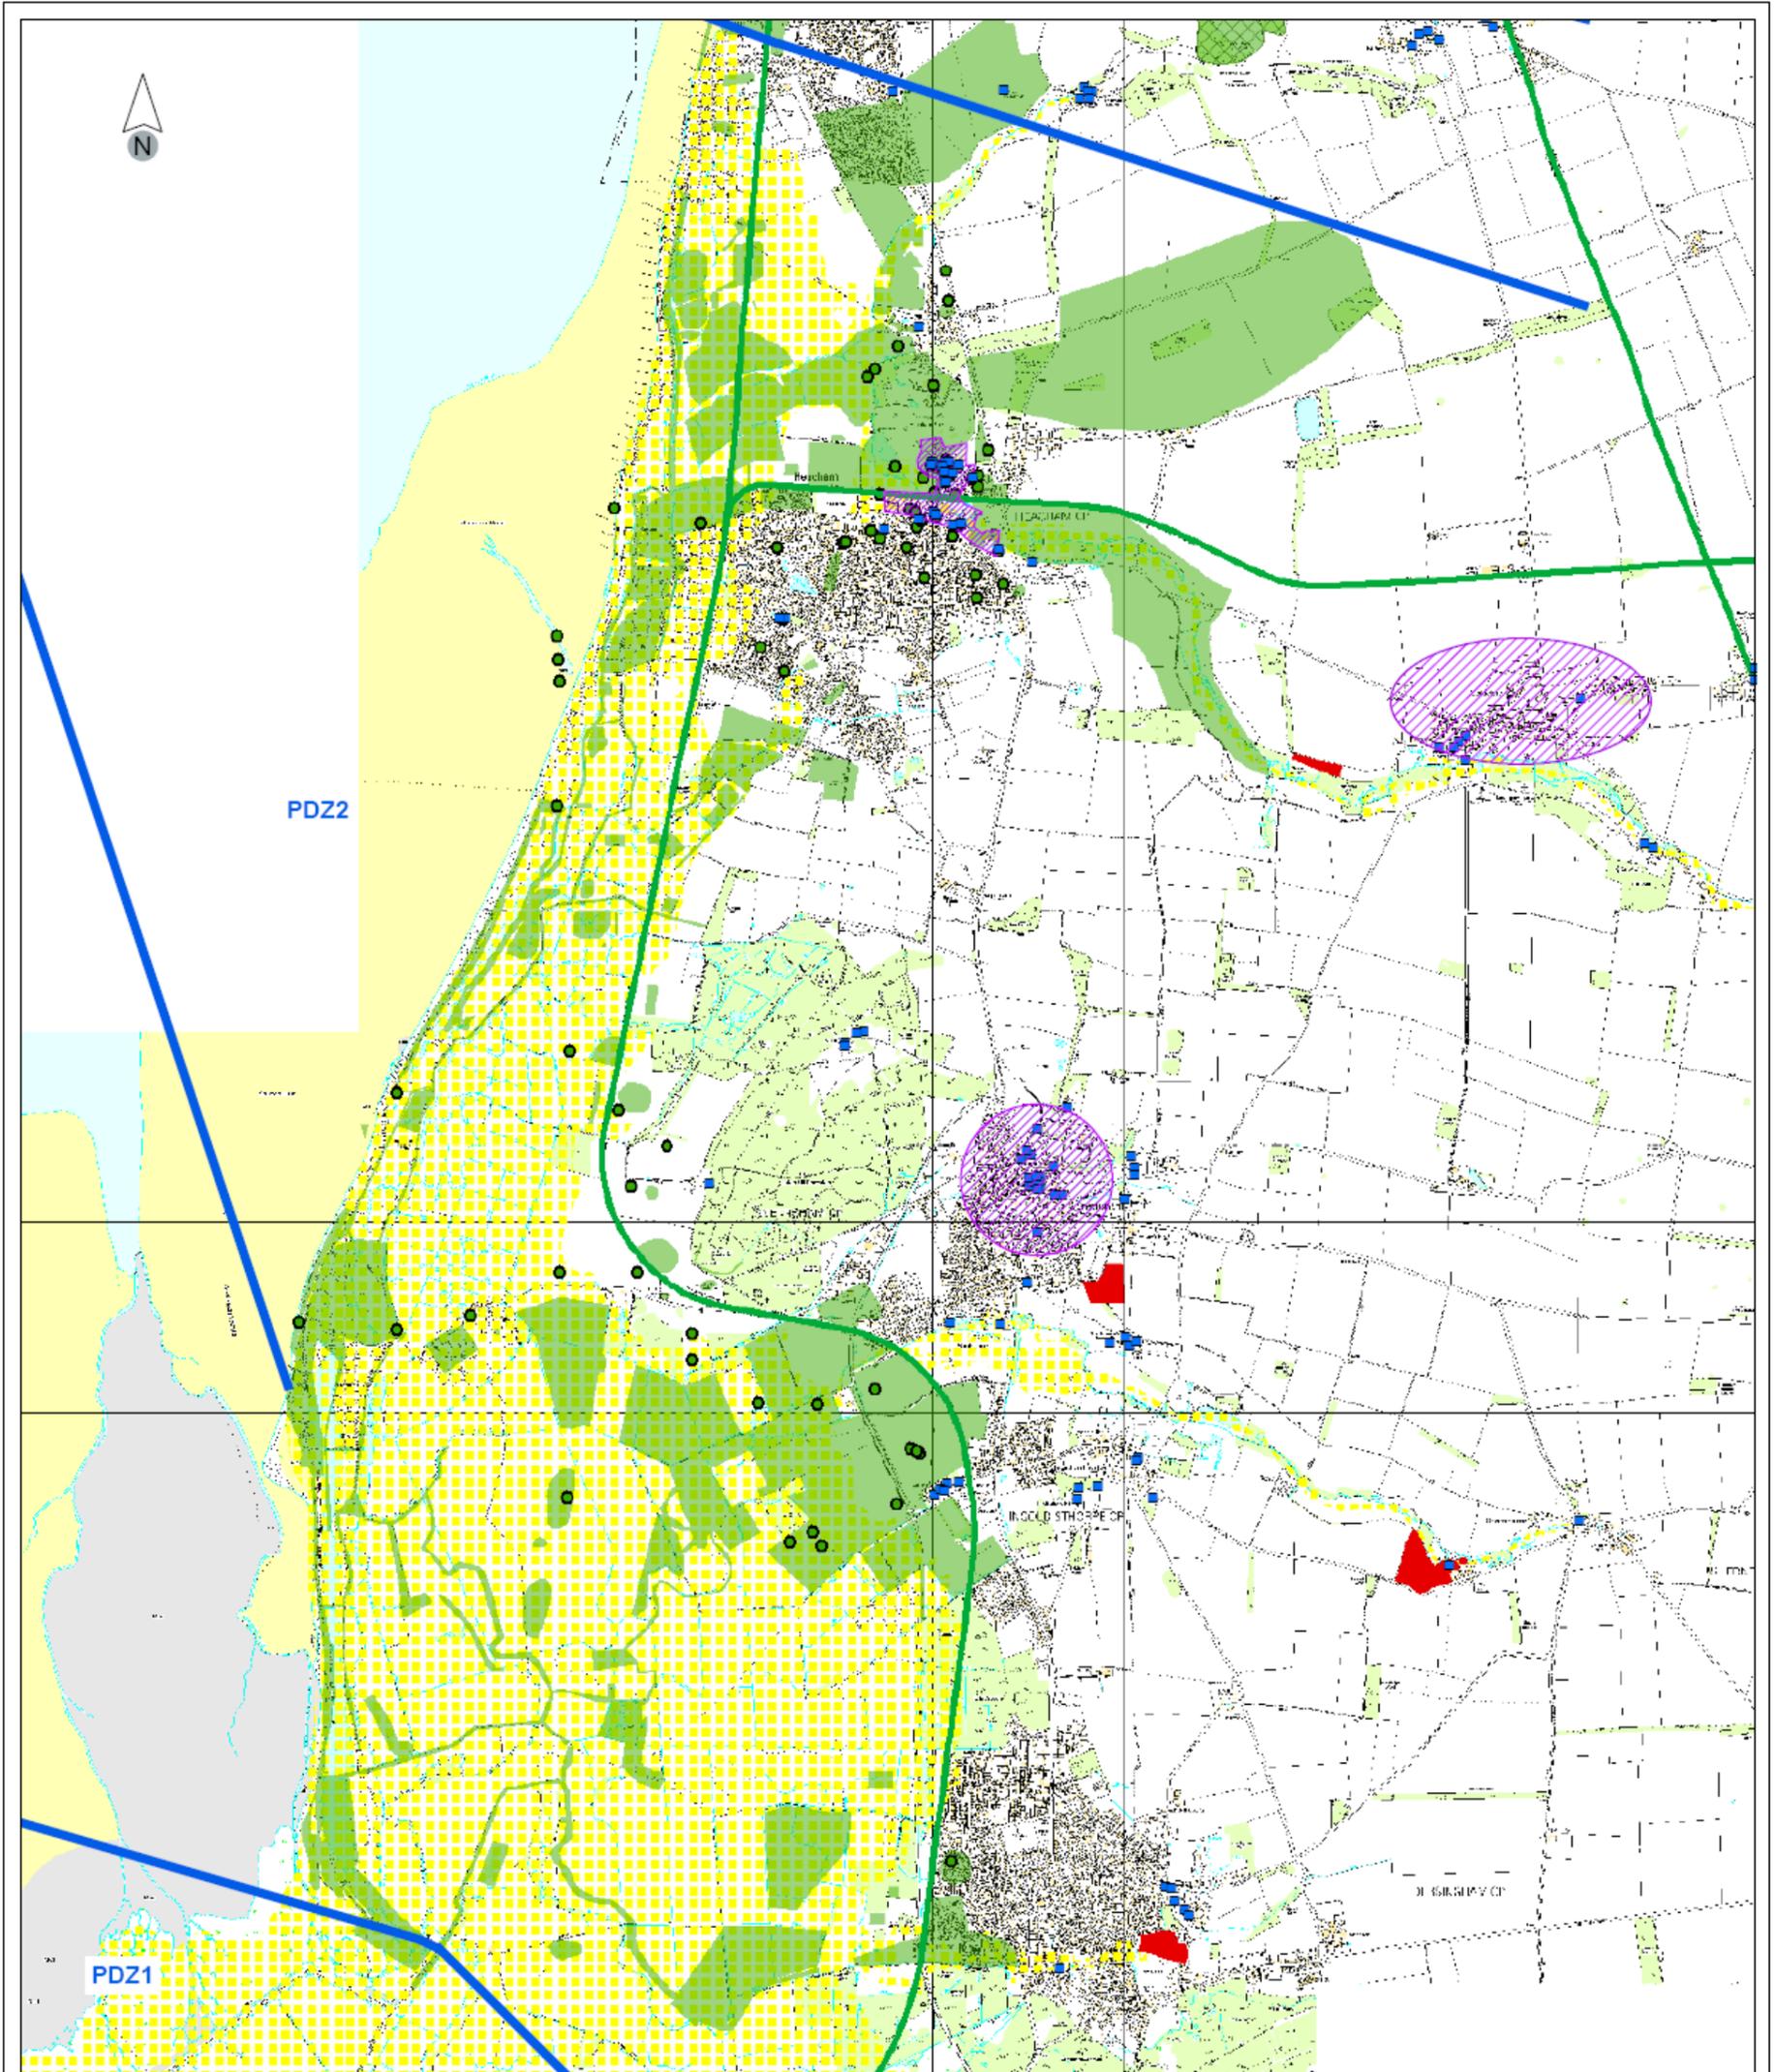
Figure A3 Designated and Non-Designated Historic Environment Assets within PDZ2

Title:
Designated and Non-Designated
Historic Environment Assets within
PDZ2 of The Wash SMP2

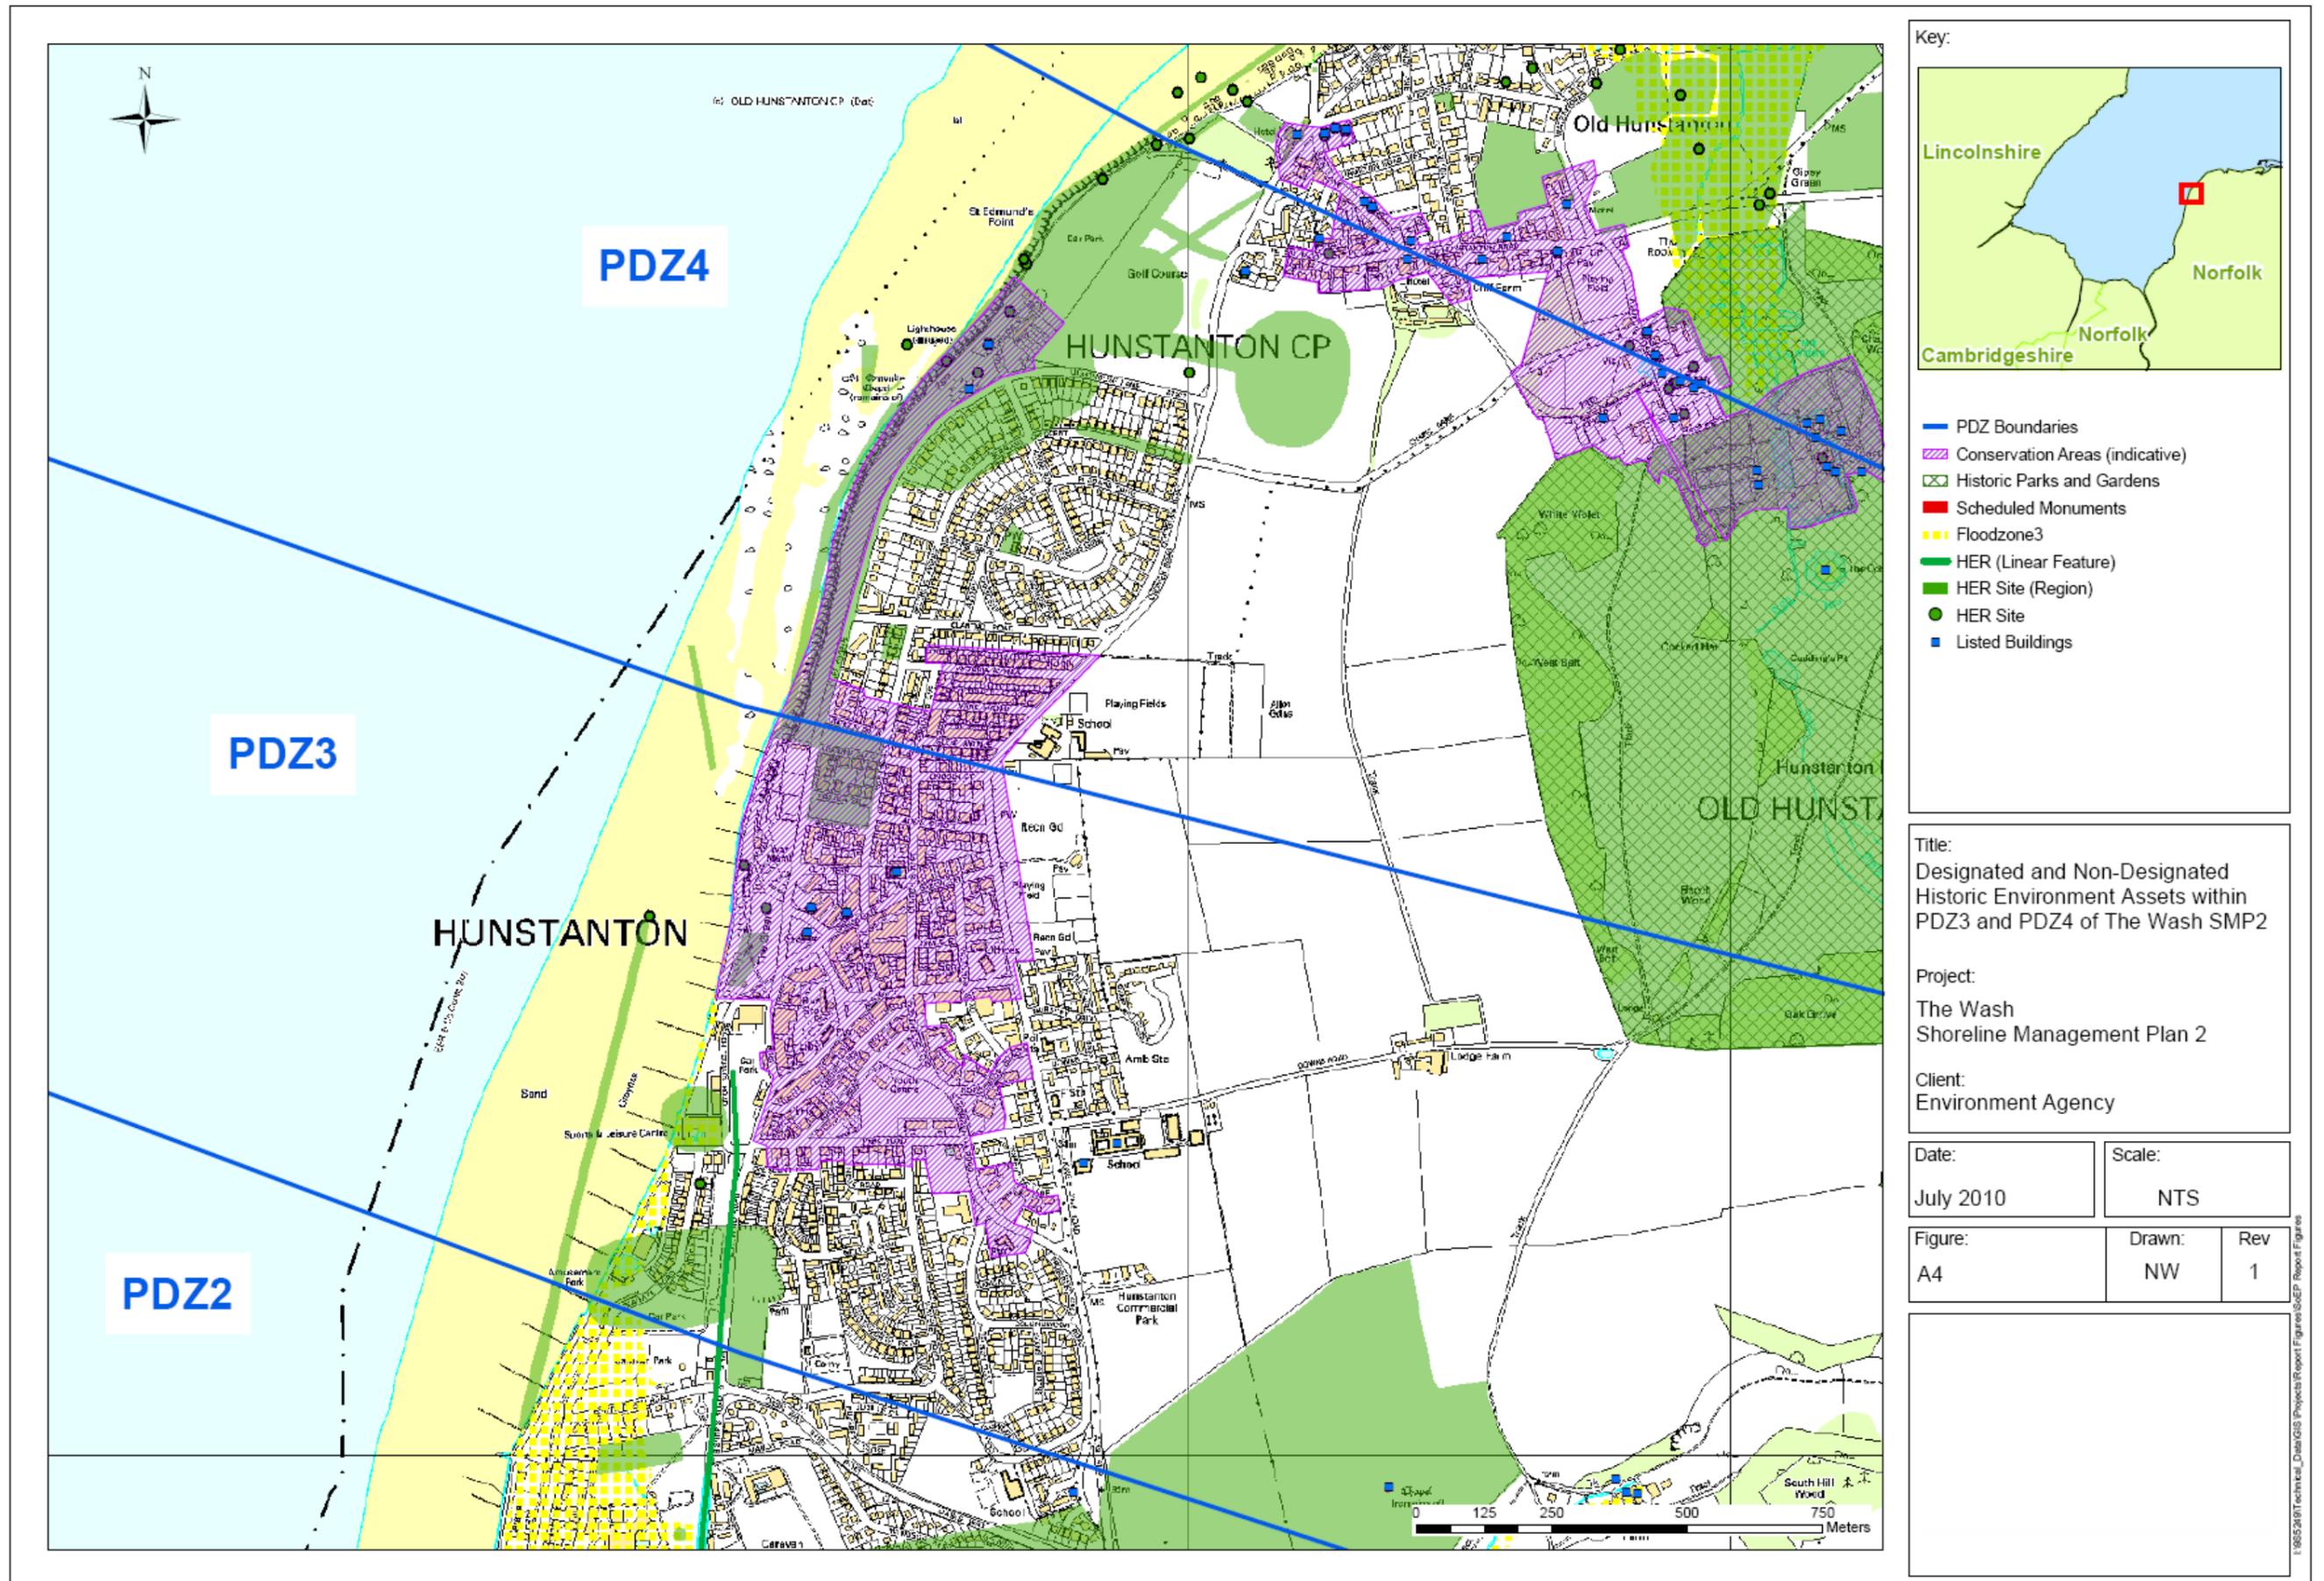
Figure A4 Designated and Non-Designated Historic Environment Assets within PDZ3 and PDZ4
